Re: FCA Response to NMFS letter dated September 3, 2009

September 25, 2009

FCA's Request

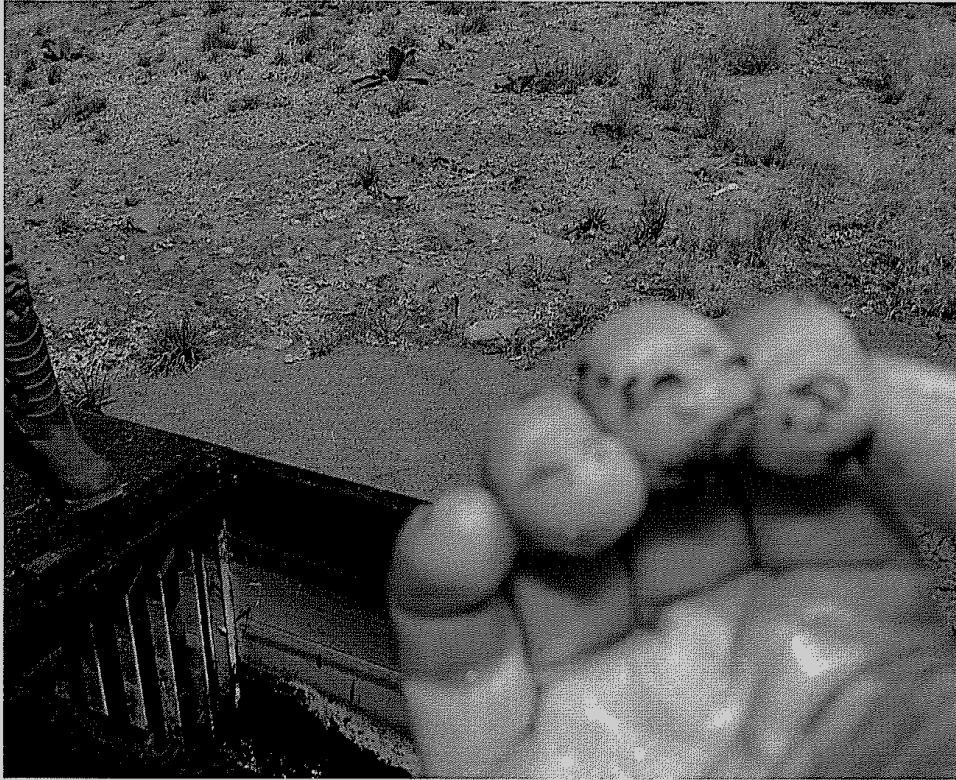
Typical of most northwest stream and river systems, inflow from Widow's Creek conveys a significant sediment and debris load. During this visit I noted that each of the three screens had some degree of debris occlusion comprised of a mixture of inorganic and organic debris (Caddis Fly, organisms that may have been Western Brook Lamprey ammocoetes or aquatic insects, small gravels, algae, and various forms of other organic materials, see Image 1). Regular fouling occurs and is documented as significant at times (see Image 2). ODFW and the ranch manager stated that the screens require cleaning at least one time per day.

Image 1, organisms found on the screen

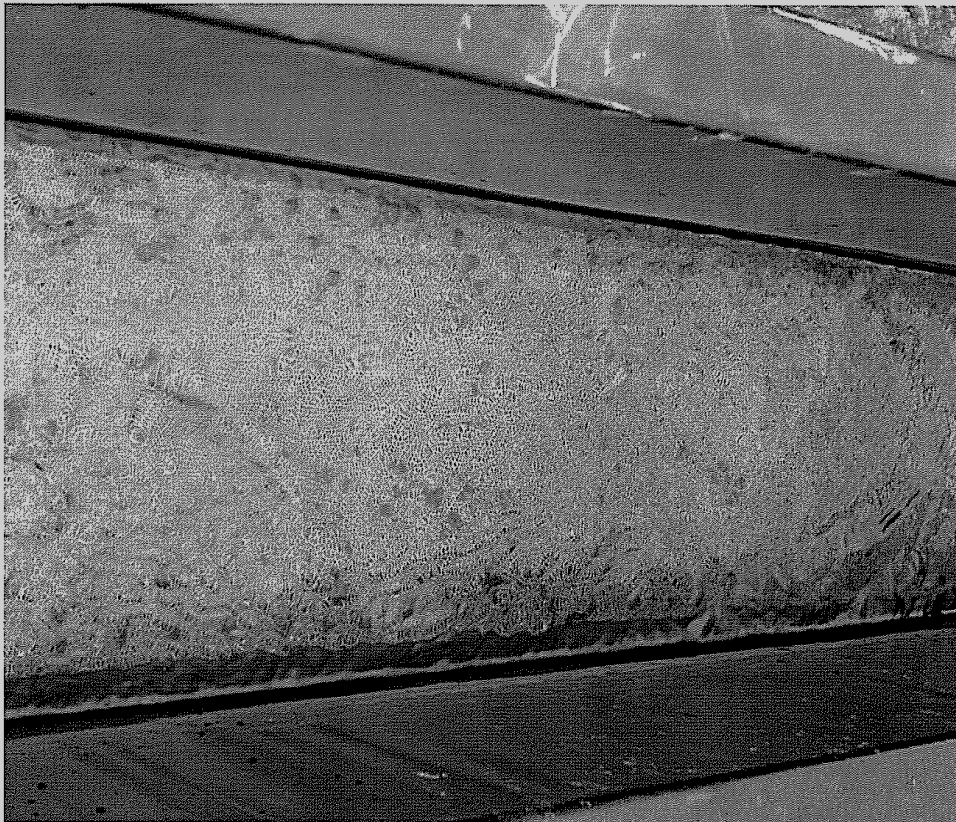
Image 2, fouling on the screens

In addition to sediment settling out and filling in the bay below the screen, it also settles out on top of the screens and at times can occlude 50 percent of the surface, or more. ODFW stated that one week prior to my inspection the top of the downstream screen was occluded by at least 50 percent with deposition of bedload material. This is a significant observance as ODFW and the ranch manager stated that the screen is cleaned at least one time per day. During my inspection, I found the screen material (perforated plate) occluded with bedload material (small gravel). This material was just the exact size to fit within the screen holes and provide a rough surface to

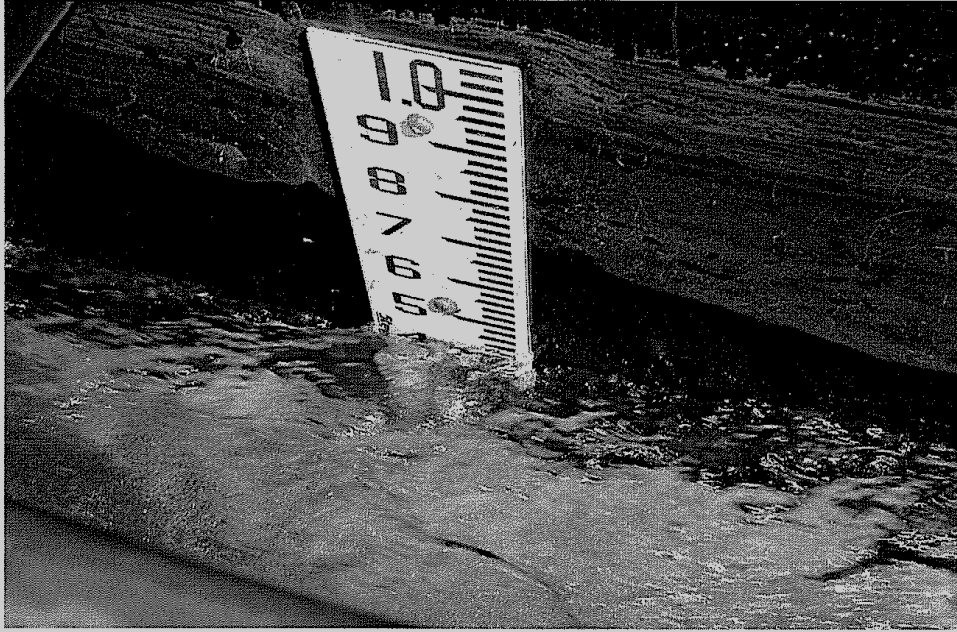
I observed the upstream screen and the middle screen operating below the "design" condition of 6 inches (the design parameter stated to us by FCA prior to installation of the Widow's Creek project). In Images 4, 5, and 6, below, Image 4 represents the upstream screen and documents the operating depth of 0.4 foot (4.8 inches), Image 5 represents the middle screen and documents the operating depth of 0.4 foot (4.8 inches) and Image 6 represents the downstream screen and documents the operating depth of 0.55 foot (6.6 inches). ODFW stated that the downstream screen was operating in an abnormal way and when I observed the screen, I noted that a large amount of return flow was conveyed in the diverted water bay, which caused the screen to backwater (Image 7). Therefore, my observation of the water depth over this screen was that it exceeded the 0.5 foot of water depth planned for by the designer, but that it likely did not represent normal operating conditions.

Image 4, upstream screen operating water depth

As stated above, these screens are not being operated as designed which means that the water depth is not being maintained at the minimum 6 inch water depth. Until the weir walls are again removed, repaired, reinstalled, then resealed properly and the flush gates on the weir walls are permanently sealed, the screens will not be able to be operated properly. (FCA has no authority to perform this work independently and must coordinate with both the landowner and ODFW. FCA and ODFW are currently in process to make these screen adjustments.) When the screens were first installed and calibrated, the screens operated as they were designed (at a 6" minimum depth).

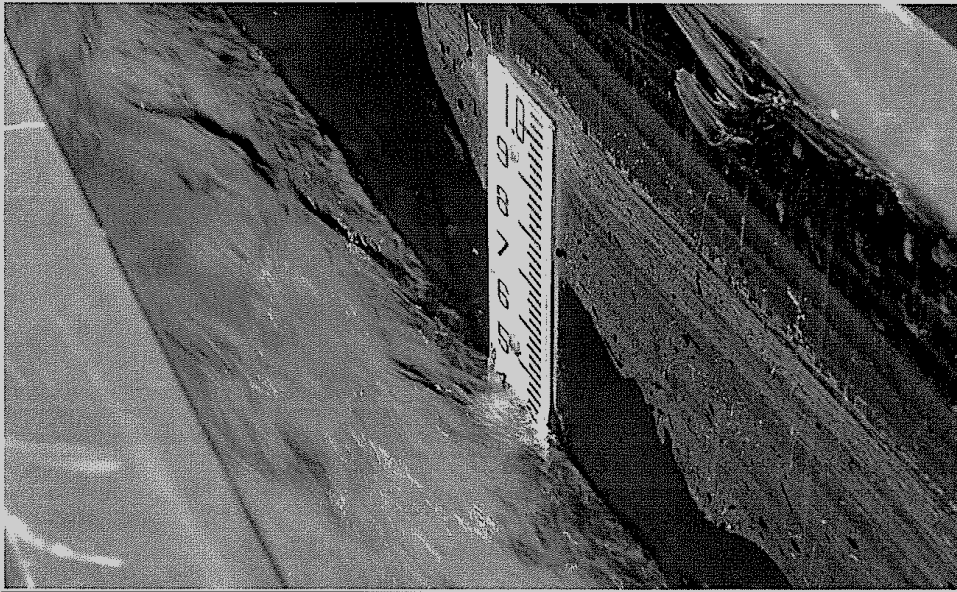
Image 5, middle screen operating water depth

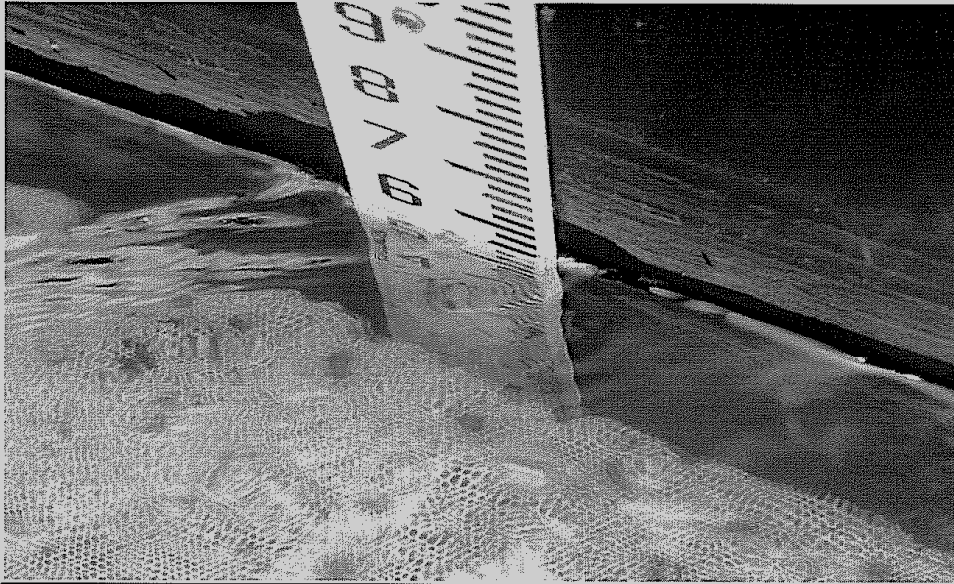
Image 6, downstream screen operating water depth

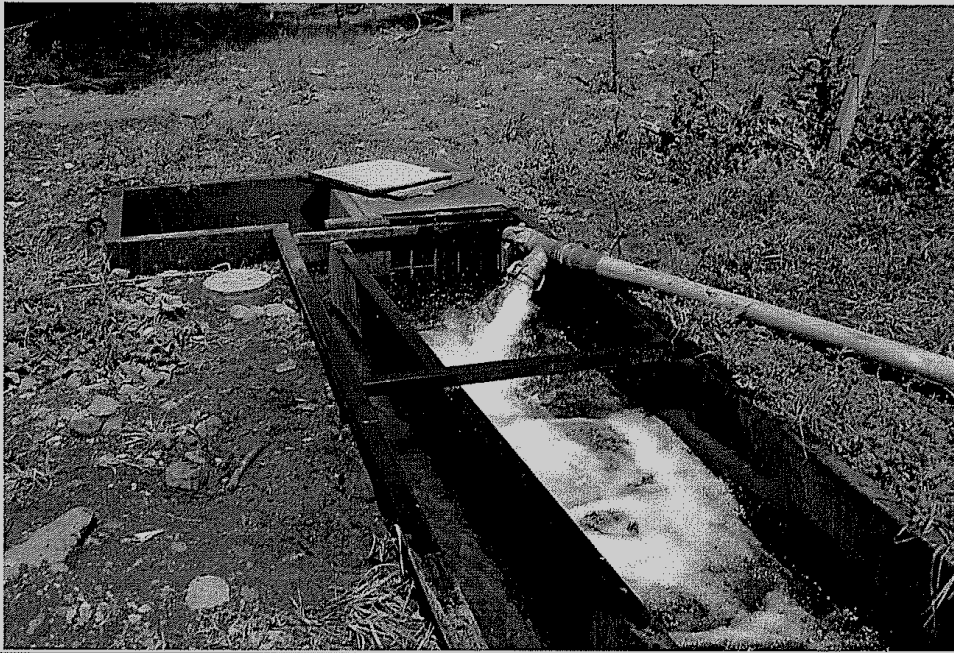
The pipe dumping water into the lower Widows Creek screen was the result of the rancher using water that had already passed through the middle Widows Creek screen. The rancher used an irrigation handline to pipe the screened water from the middle Widows Creek screen to the lower Widows Creek screen in order to increase the screened water flow at the lower screen site. Although this conveyance system looks odd, it does not alter screen performance. FCA believes a better solution would be to shut off the middle screen, leave the water in Widows Creek, then capture the water through the lower screen diversion.

Image 7, downstream screen unusual operation with return flow to diverted water bay backwatering screen

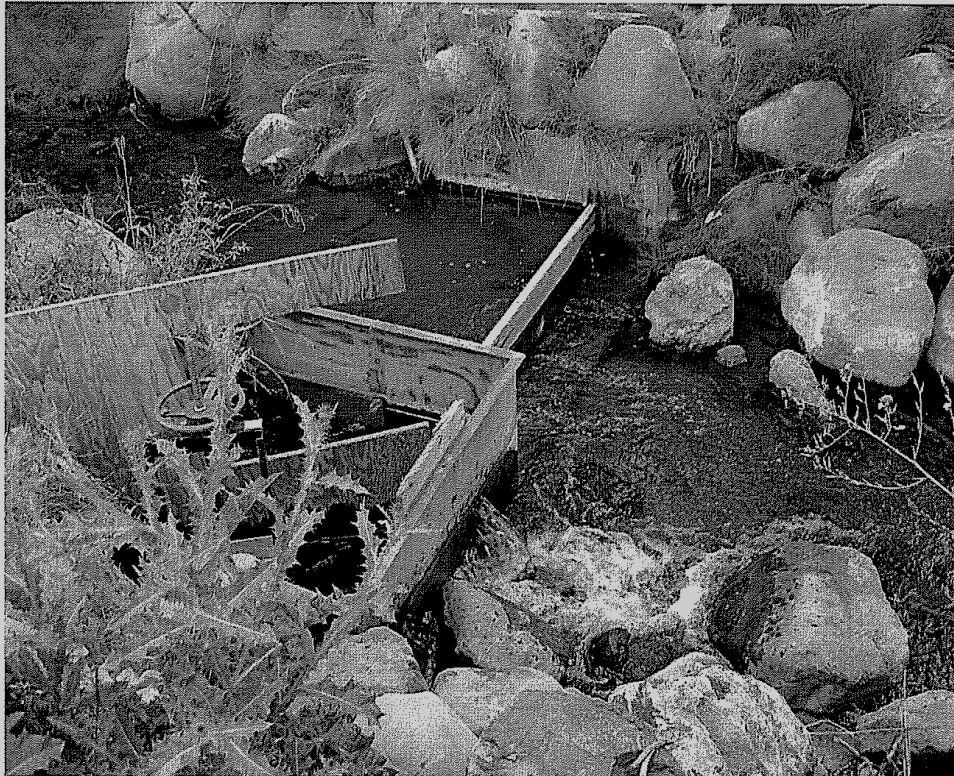
Two issues related to the bypass operation were reported by ODFW. Late in the operating season, no flow in excess of the diverted flow will be available for bypass, meaning that the bypass will be closed. This is a concern and violates the criteria the special FCA screen criteria. Also, I observed that even with flow available for bypass, fish are routed directly below the screens. I observed fish below the diversion structures. The three diversions provide a complete passage barrier to any fish interested in passing upstream (image 8).

Image 8, upstream passage barrier
