# UTILIZATION OF SUBMERSIBLE CAMERAS IN FISH SCREEN MONITORING AND EVALUATION

**GREG LOWELL**  
Fisheries Technician  
Idaho Fish and Game  
Anadromous Fish Screening Program

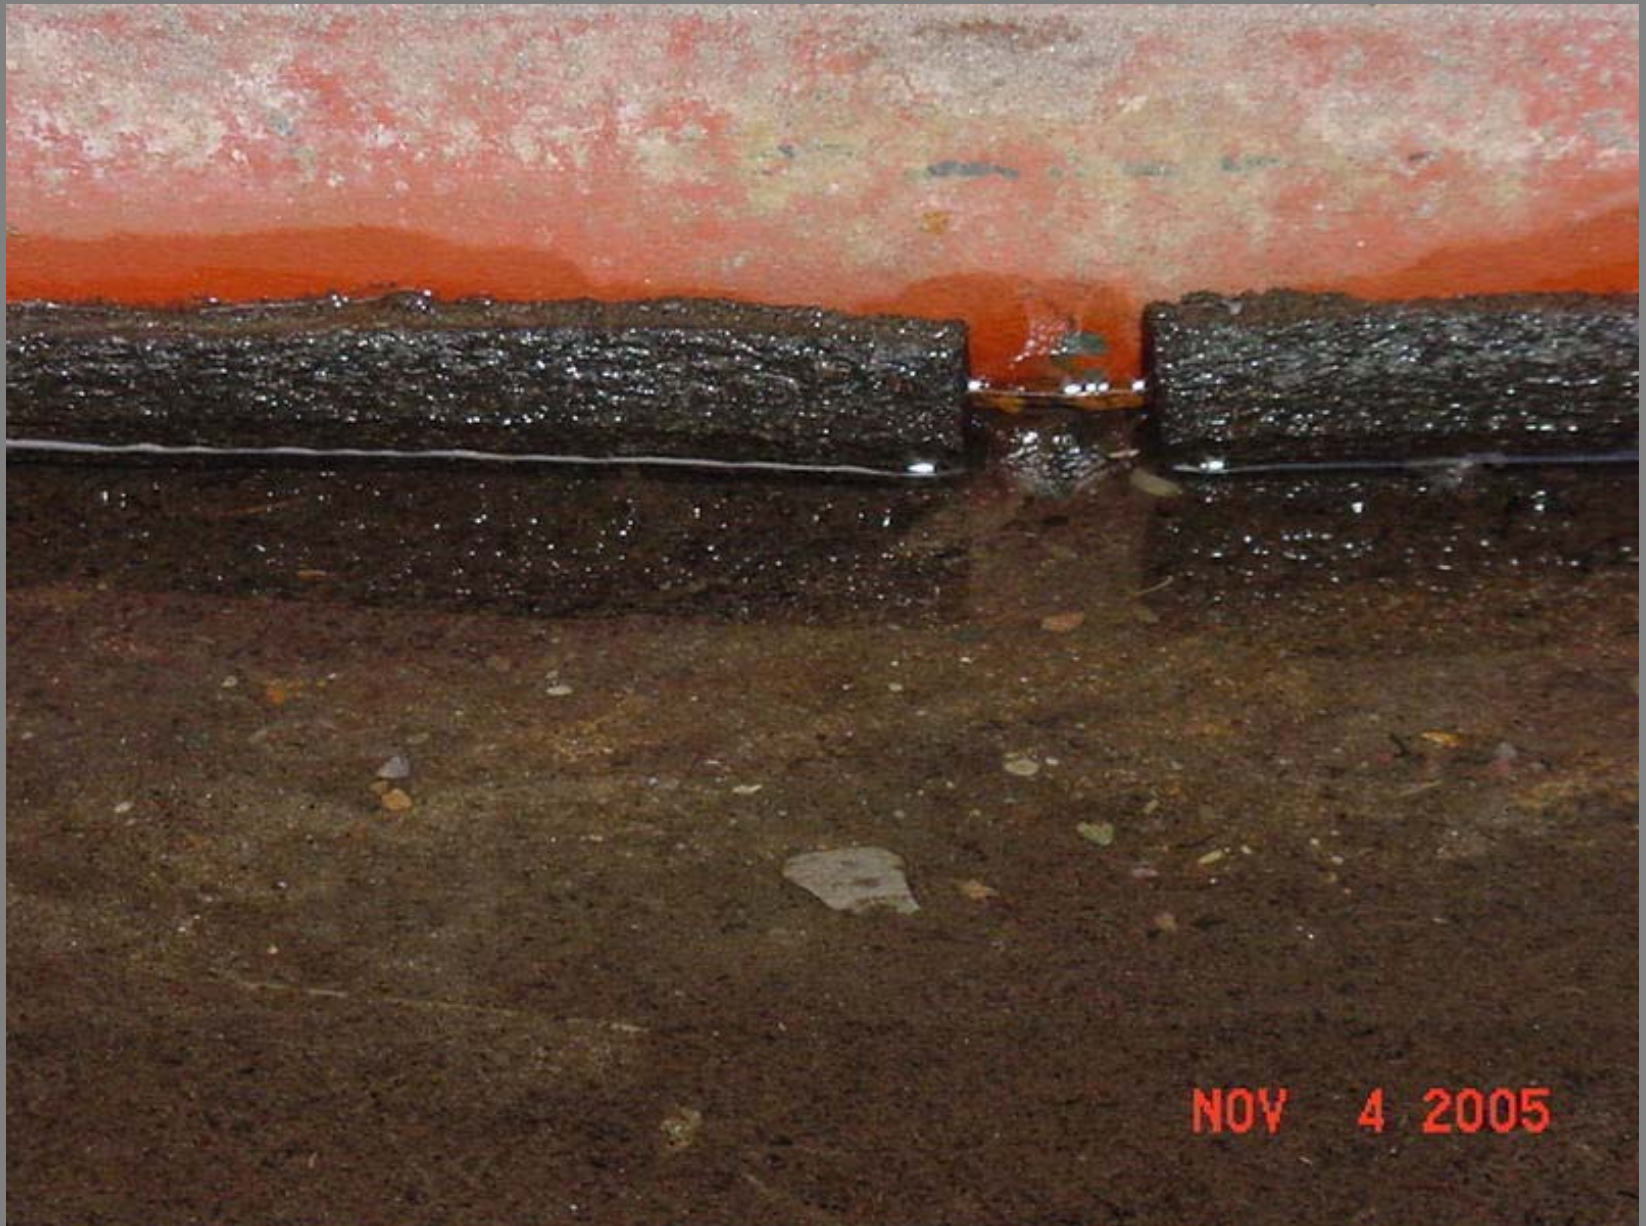
# COMPROMISED FOAM SEAL

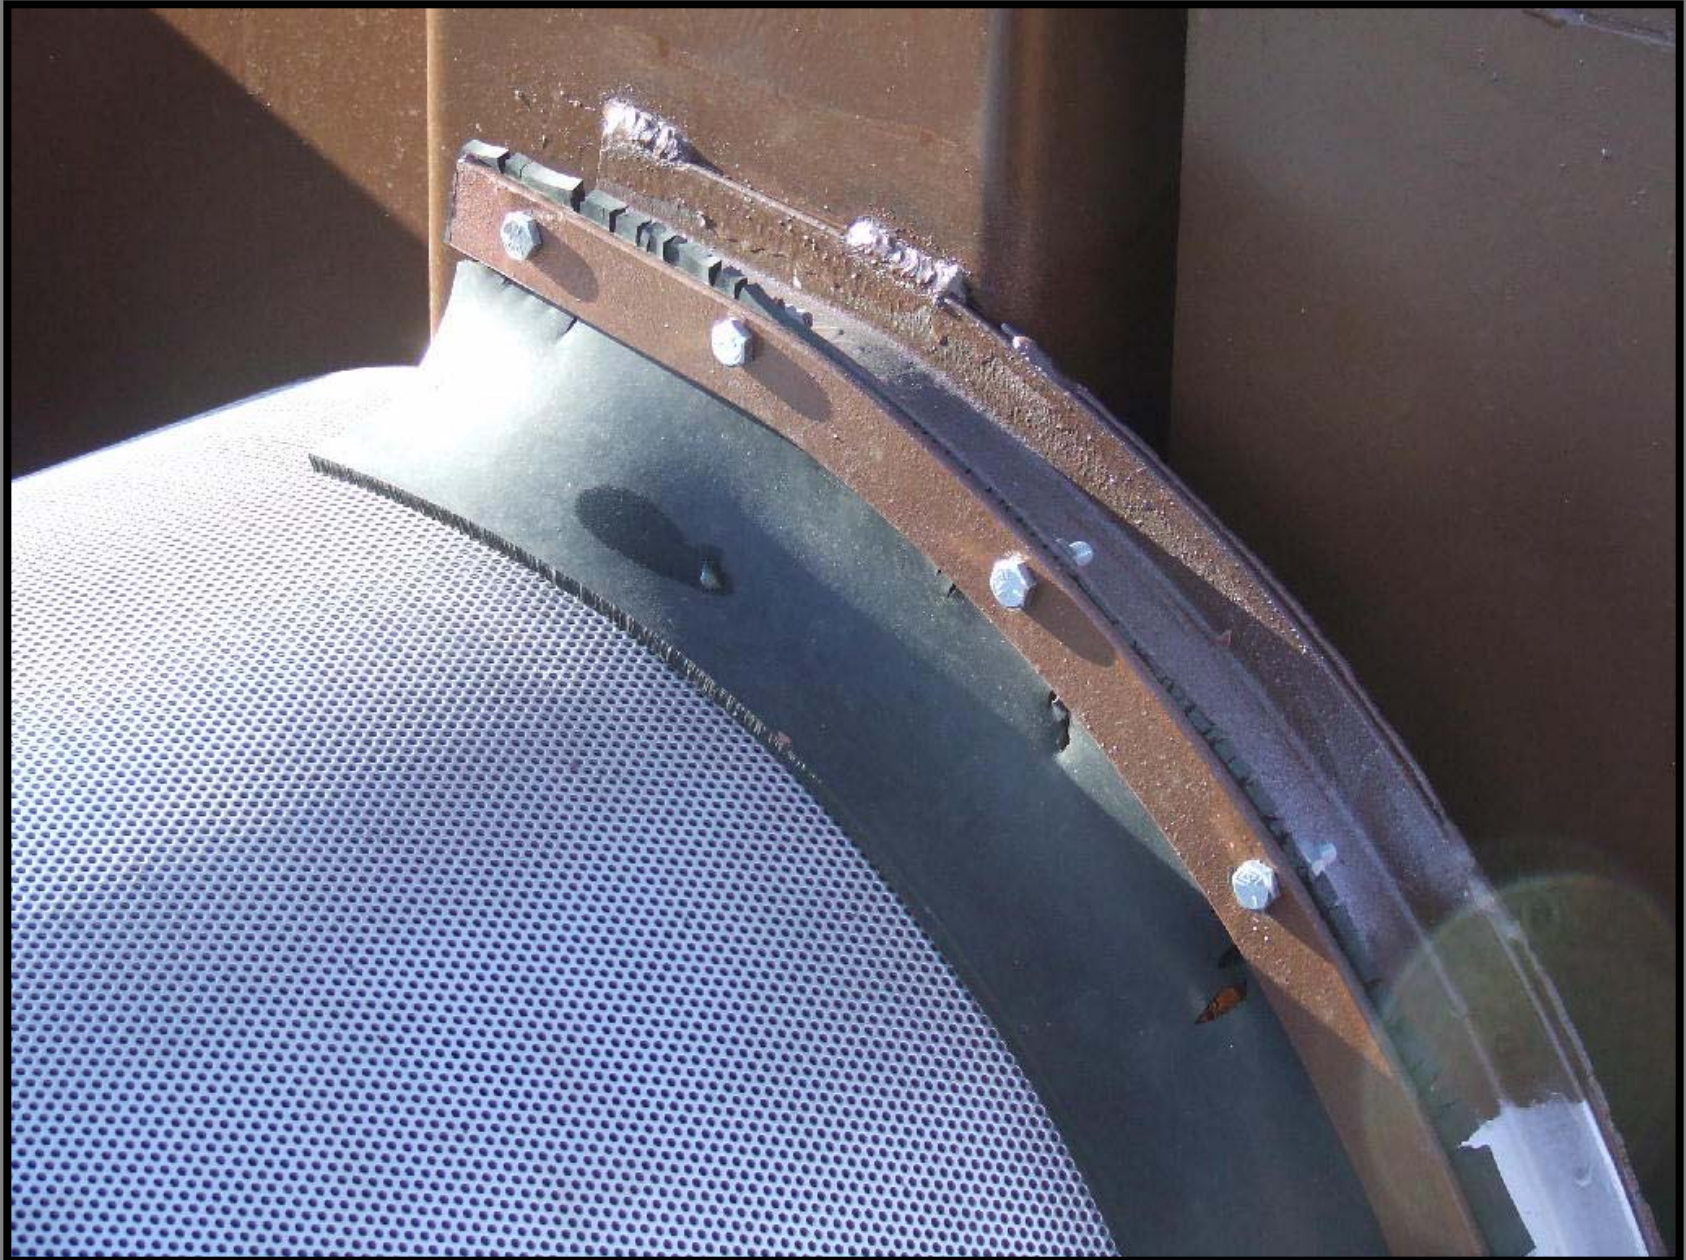
# SEAL SIDE DETERIORATION

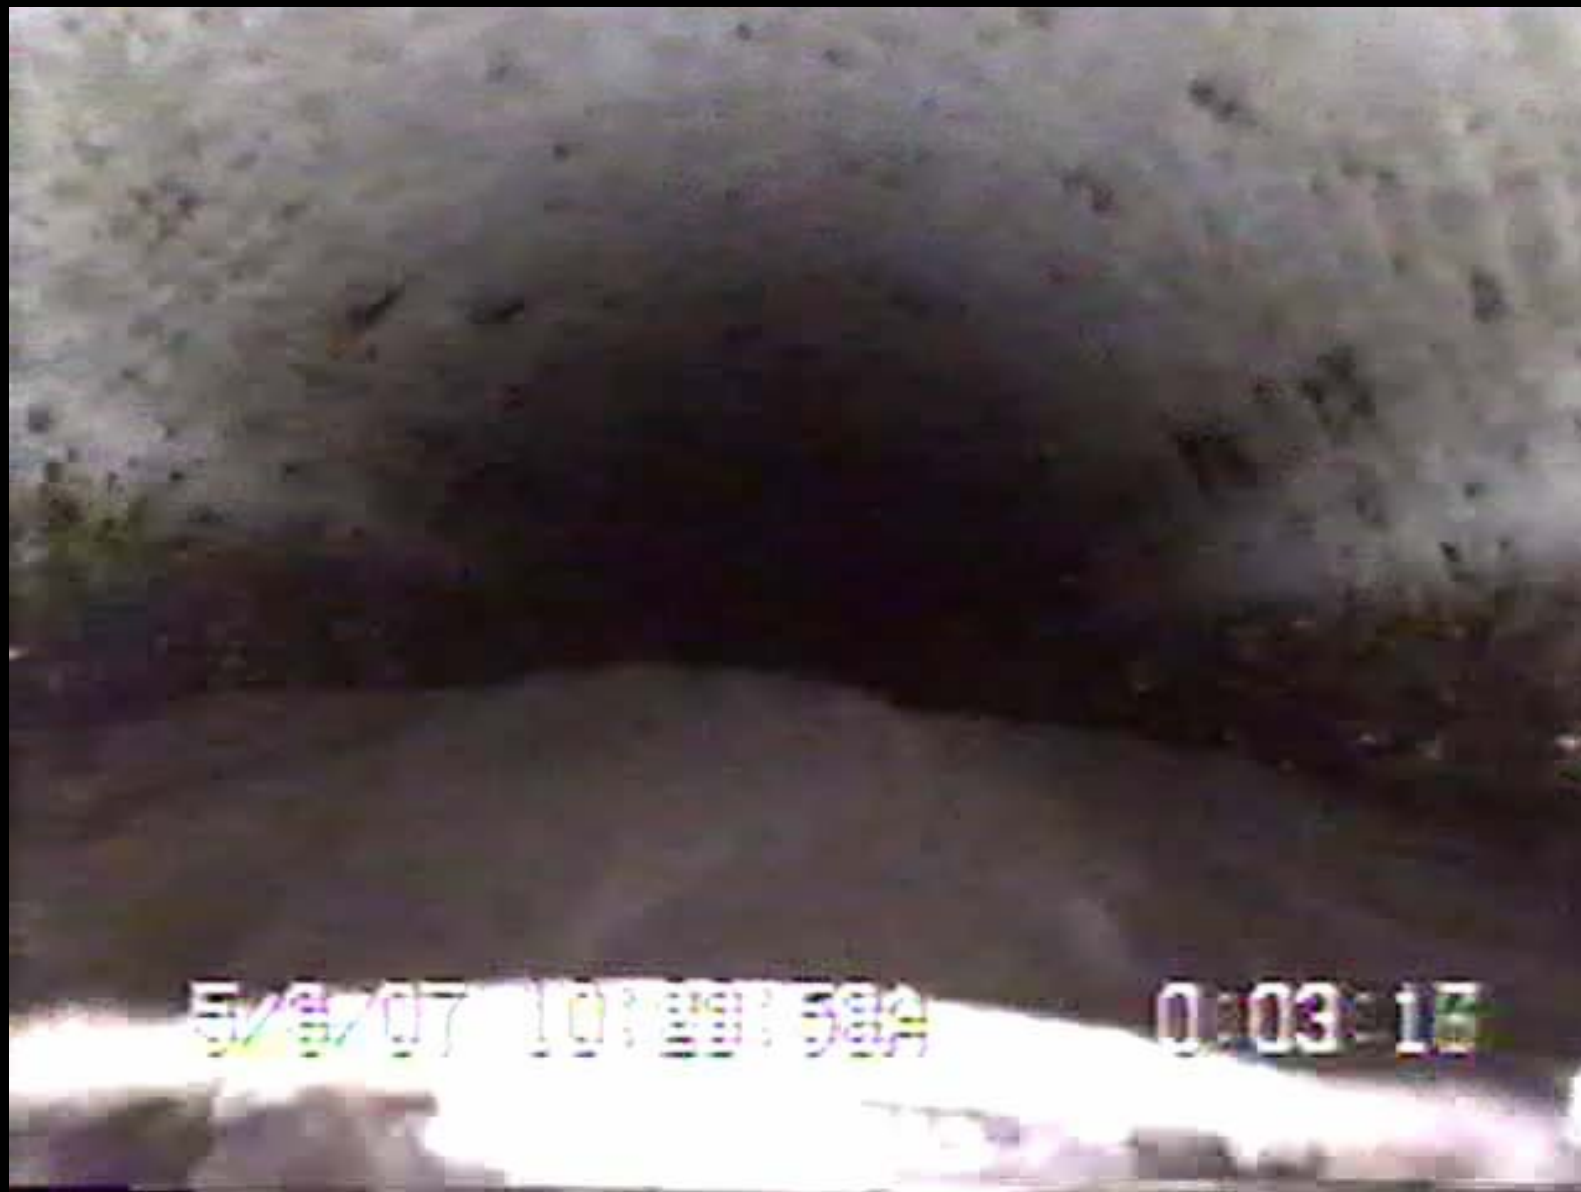
# MISALIGNED PIPE SECTIONS

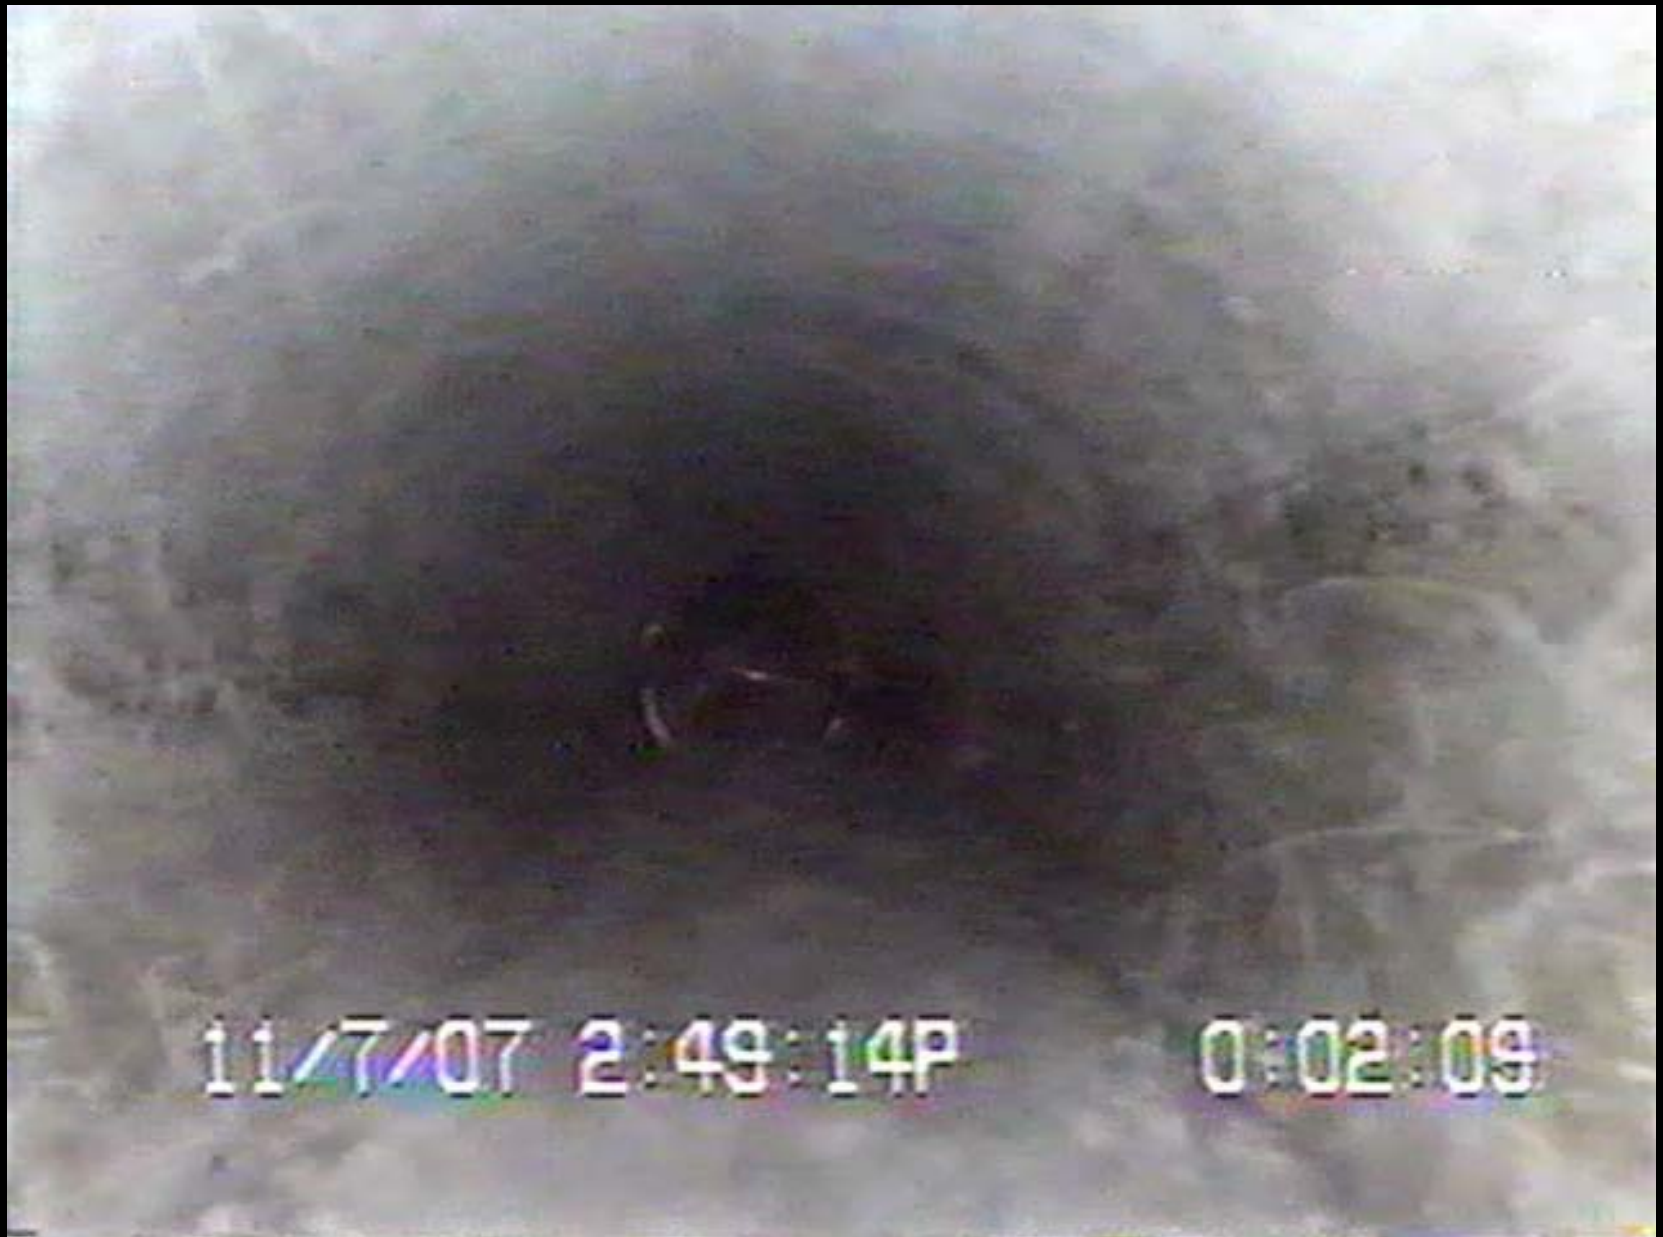
# DISPLACED GASKET SEAL

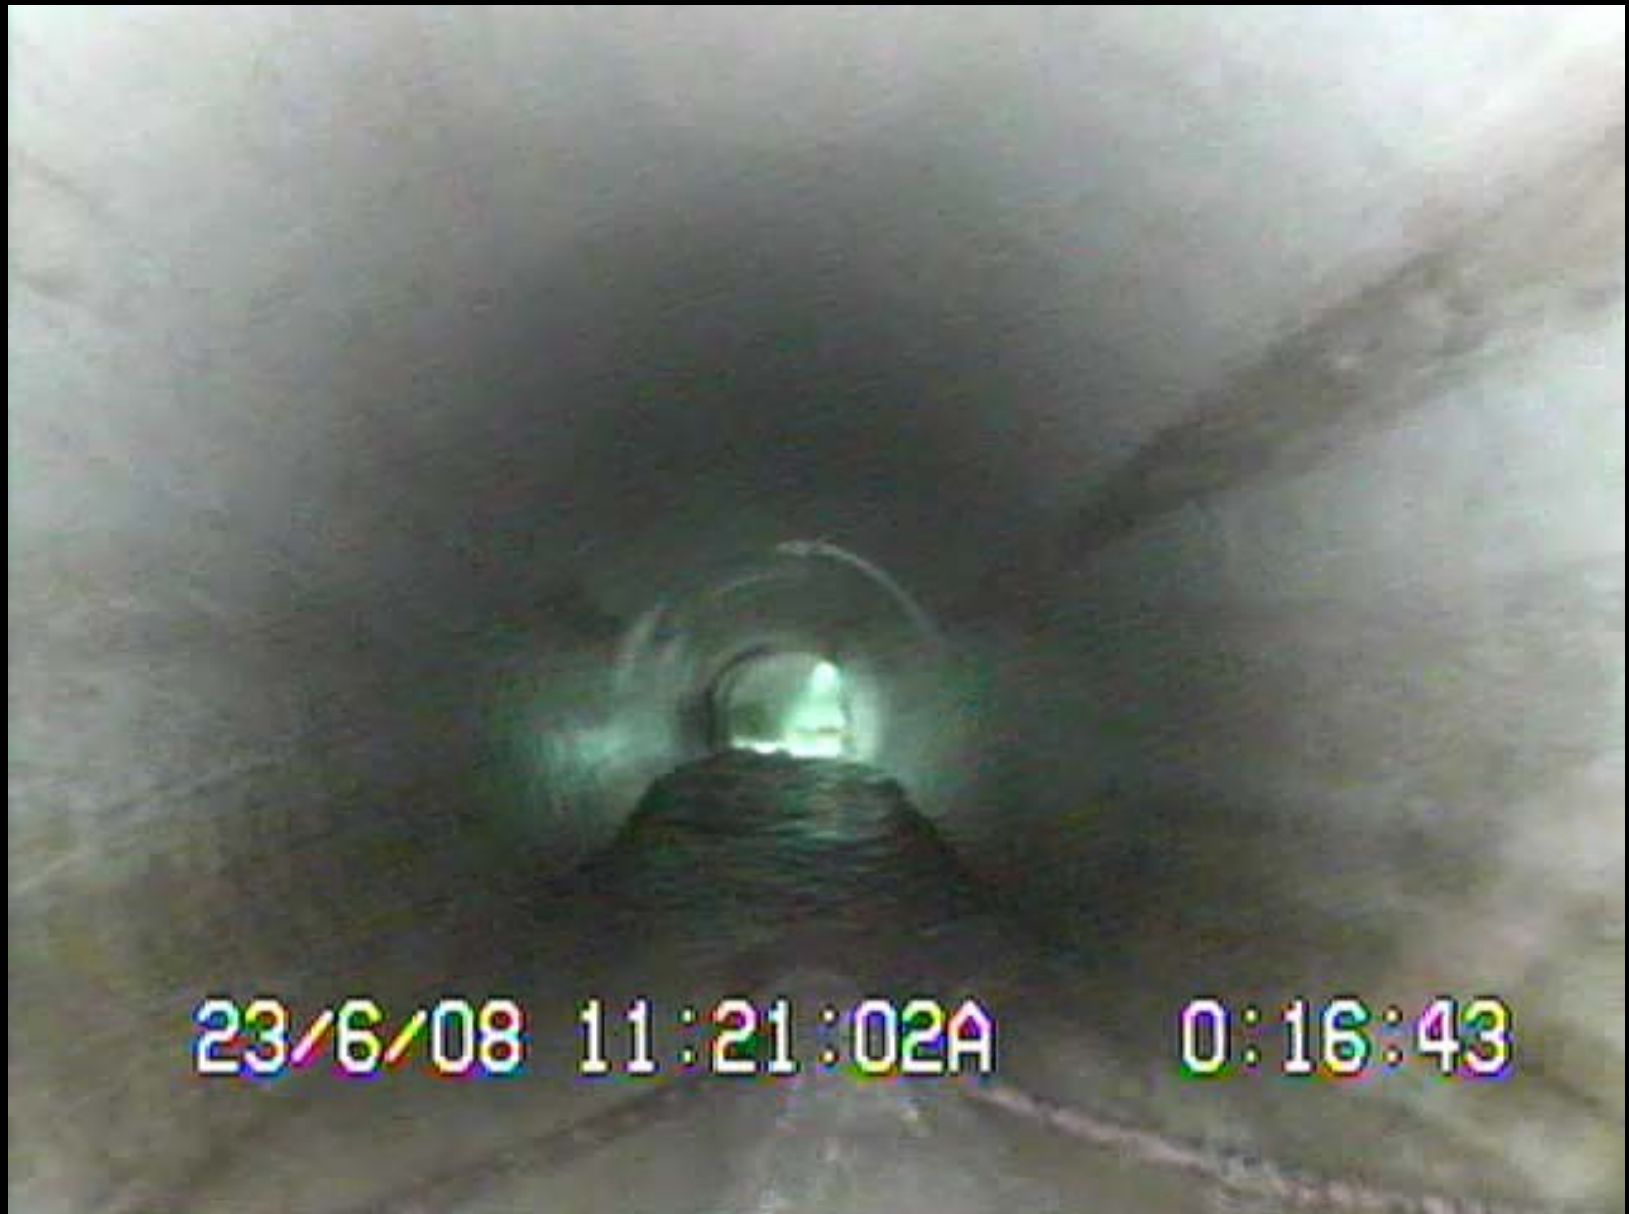
# SEDIMENT ACCUMULATION

# CLEANOUT
