UNITED STATES DEPARTMENT OF COMMERCE
National Oceanic and Atmospheric Administration
NATIONAL MARINE FISHERIES SERVICE
1201 NE Lloyd Boulevard, Suite 1100
PORTLAND, OREGON 97232-1274

Re: Assessment of status of Farmers Conservation Alliance (FCA) Horizontal Screens as an Experimental Fish passage Technology

Enclosure 2 - Operation, Siting, and Design Criteria¹

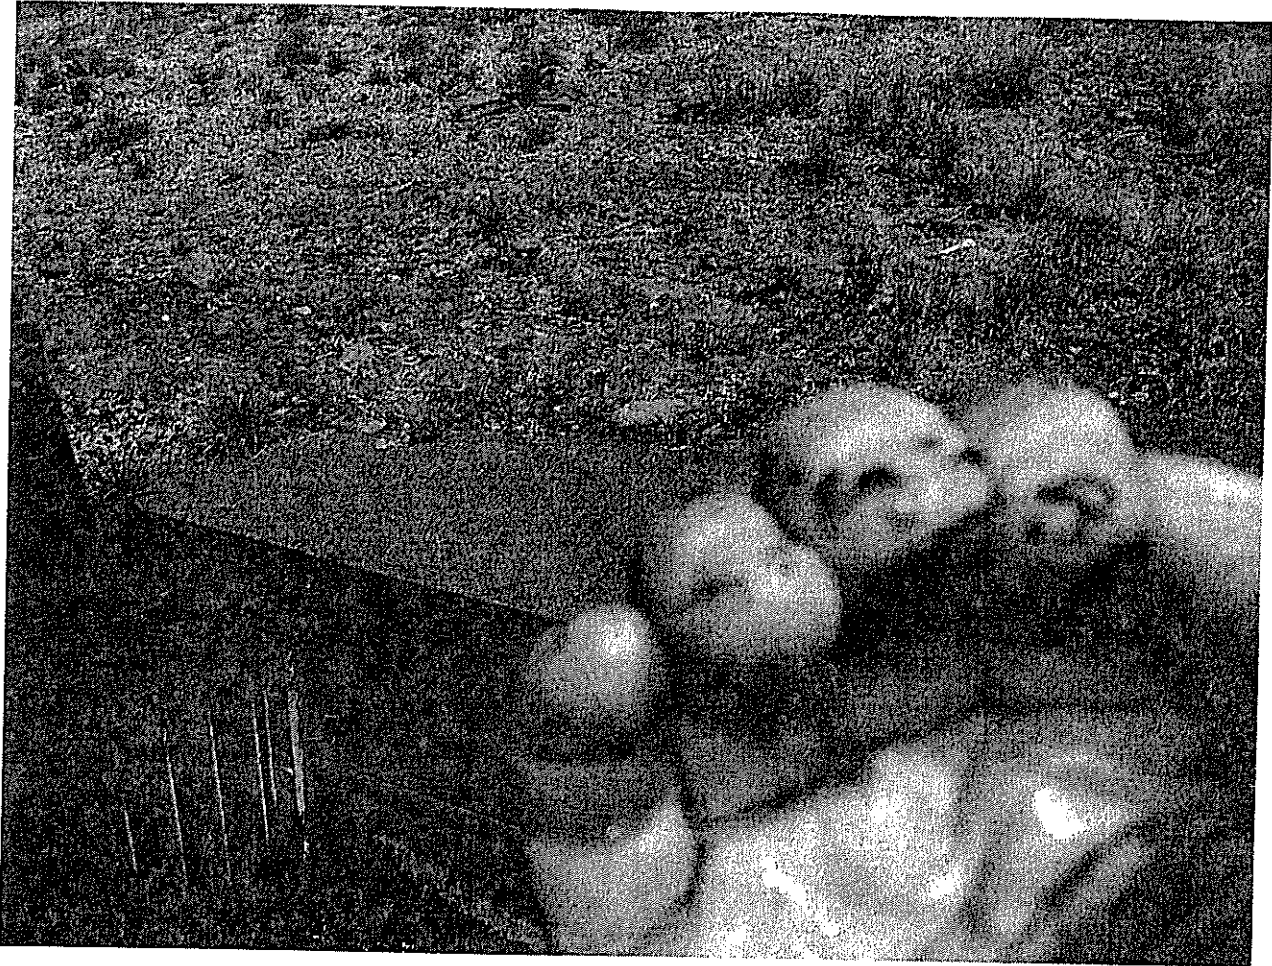
During our tour of the downstream screen, I observed fish on the screen, maintaining location, which may indicate delay on top of the screen. In fact, my shadow caused these fish to move up and down the screen. The water surface was maintained between 0.4 feet (4.8 inches) and 0.55 feet (6.6 inches) (varying between the different screens, with the upstream screen operating at 0.4 foot (4.8 inches) and the middle screen at 0.4 foot (4.8 inches) and the lowest screen at 0.55 foot (6.6 inches), with the lowest screen operating in an unusual mode, see the discussion below). This illustrated an opportunity for fish to hold up on the screen. The fish were readily visible to and could be spotted by a predator.

Image 1, organisms found on the screen

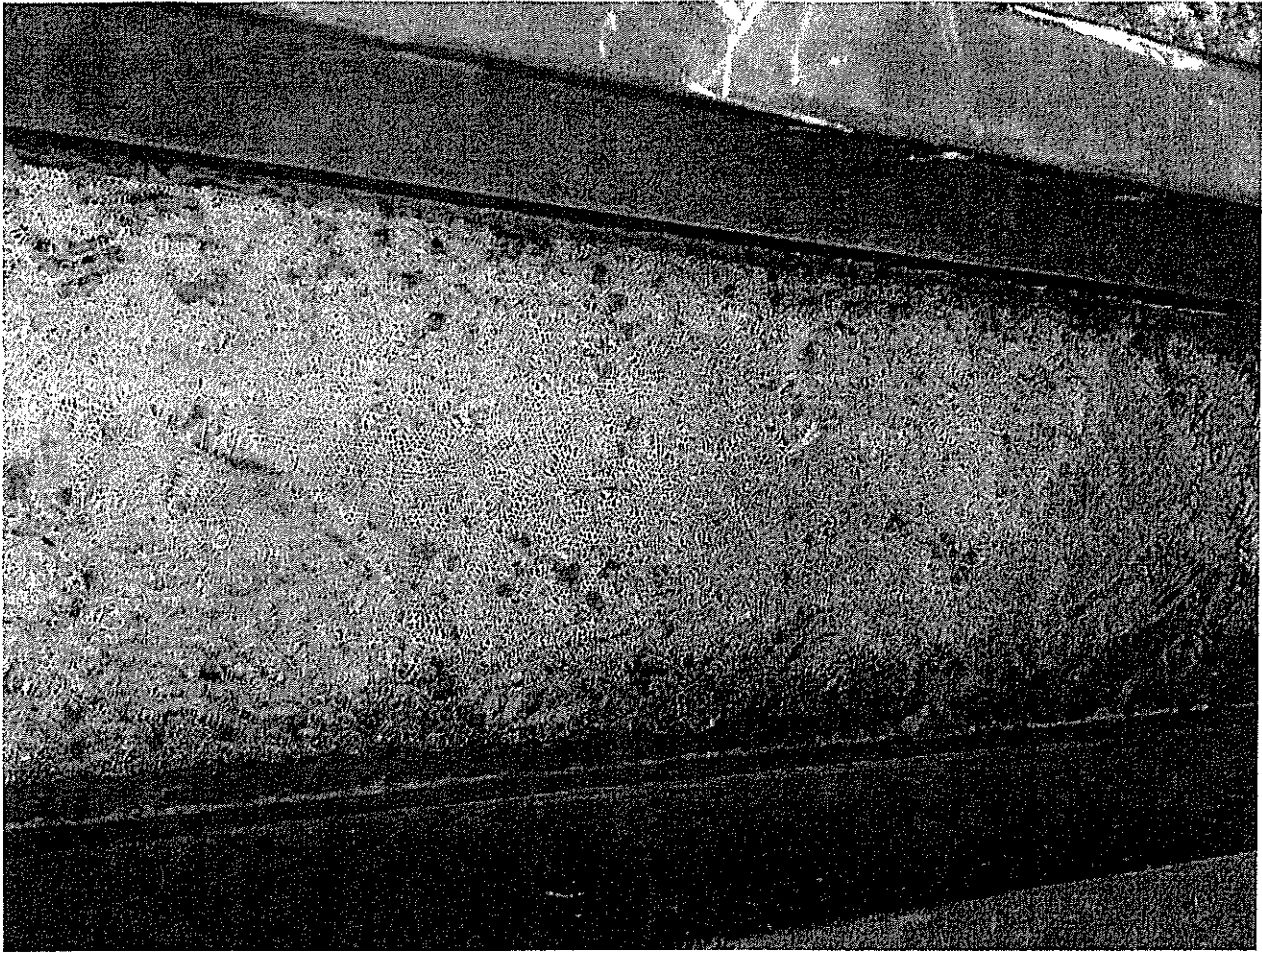
Typical of most northwest stream and river systems, inflow from Widow's Creek conveys a significant sediment and debris load. During this visit I noted that each of the three screens had some degree of debris occlusion comprised of a mixture of inorganic and organic debris (Caddis Fly, organisms that may have been Western Brook Lamprey ammocoetes or aquatic insects, small gravels, algae, and various forms of other organic materials, see Image 1). Regular fouling occurs and is documented as significant at times (see Image 2). ODFW and the ranch manager stated that the screens require cleaning at least one time per day.

Image 2, fouling on the screens

In addition to sediment settling out and filling in the bay below the screen, it also settles out on top of the screens and at times can occlude 50 percent of the surface, or more. ODFW stated that one week prior to my inspection the top of the downstream screen was occluded by at least 50 percent with deposition of bedload material. This is a significant observance as ODFW and the ranch manager stated that the screen is cleaned at least one time per day. During my inspection, I found the screen material (perforated plate) occluded with bedload material (small gravel). This material was just the exact size to fit within the screen holes and provide a rough surface to

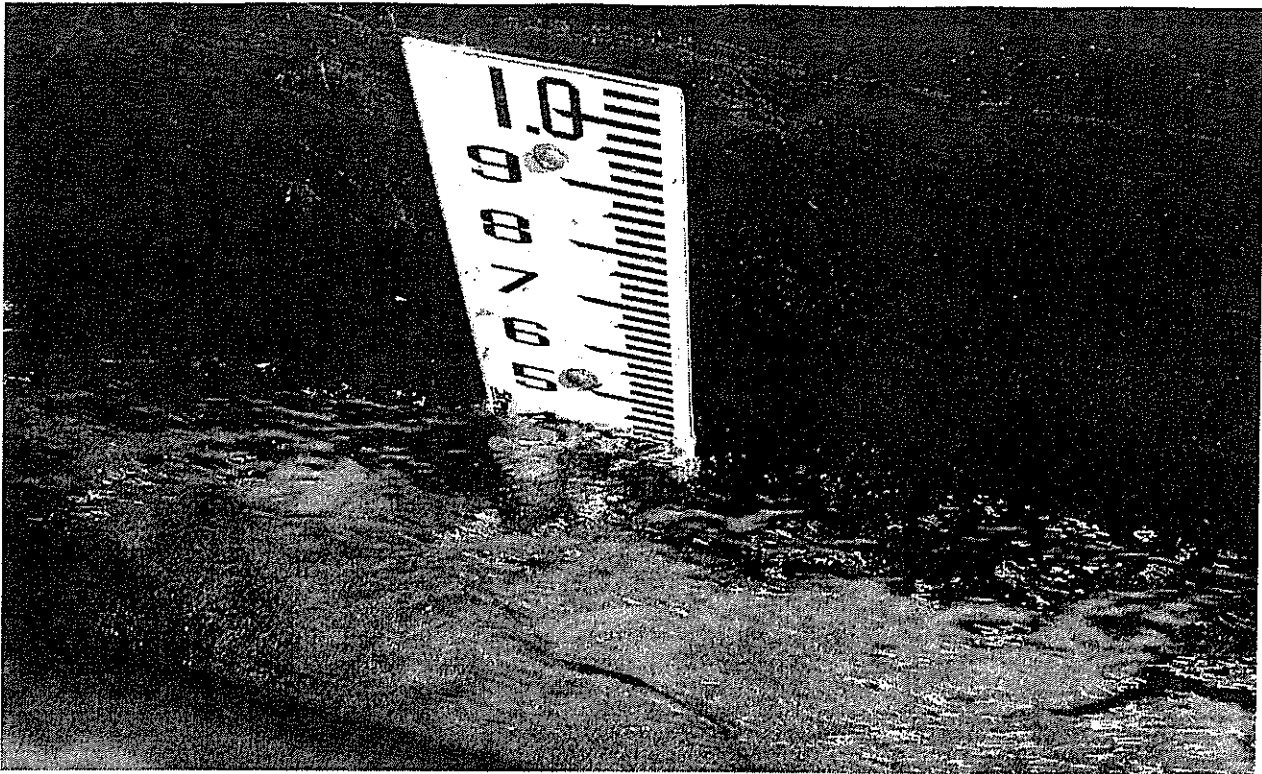
I observed the upstream screen and the middle screen operating below the “design” condition of 6 inches (the design parameter stated to us by FCA prior to installation of the Widow’s Creek project). In Images 4, 5, and 6, below, Image 4 represents the upstream screen and documents the operating depth of 0.4 foot (4.8 inches), Image 5 represents the middle screen and documents the operating depth of 0.4 foot (4.8 inches) and Image 6 represents the downstream screen and documents the operating depth of 0.55 foot (6.6 inches). ODFW stated that the downstream screen was operating in an abnormal way and when I observed the screen, I noted that a large amount of return flow was conveyed in the diverted water bay, which caused the screen to backwater (Image 7). Therefore, my observation of the water depth over this screen was that it exceeded the 0.5 foot of water depth planned for by the designer, but that it likely did not represent normal operating conditions.

Image 4, upstream screen operating water depth

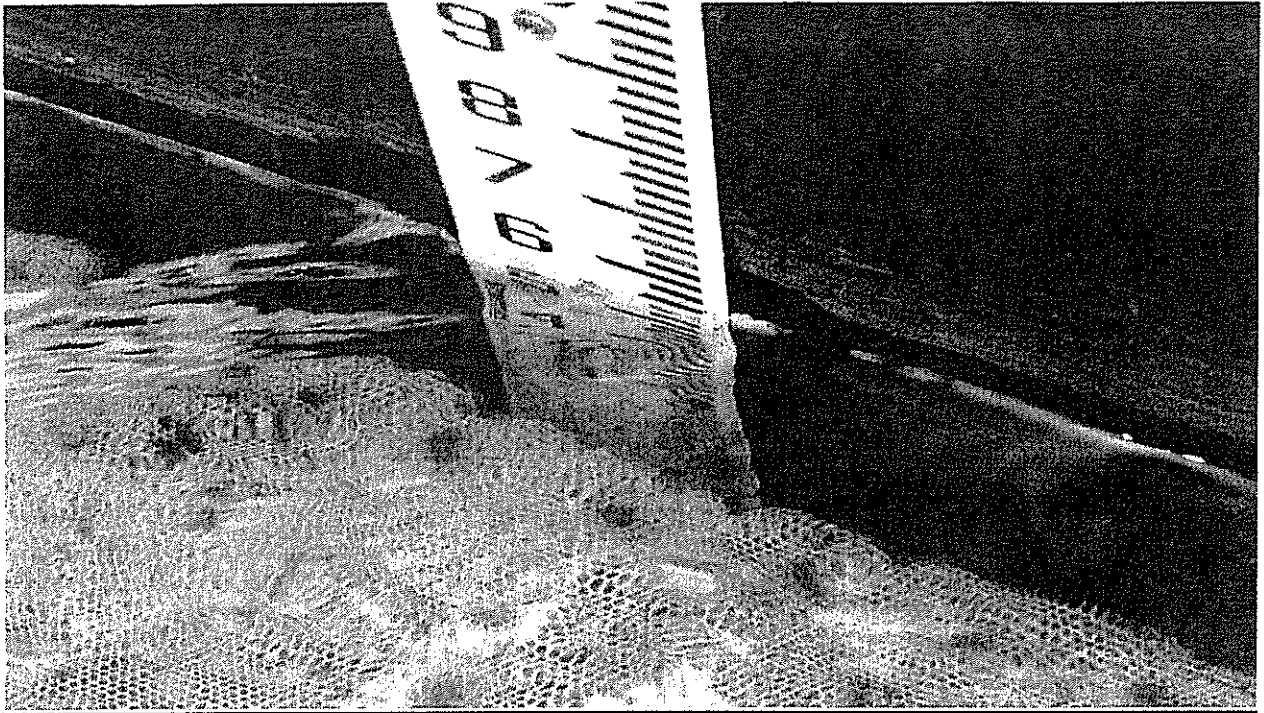
Image 6, downstream screen operating water depth

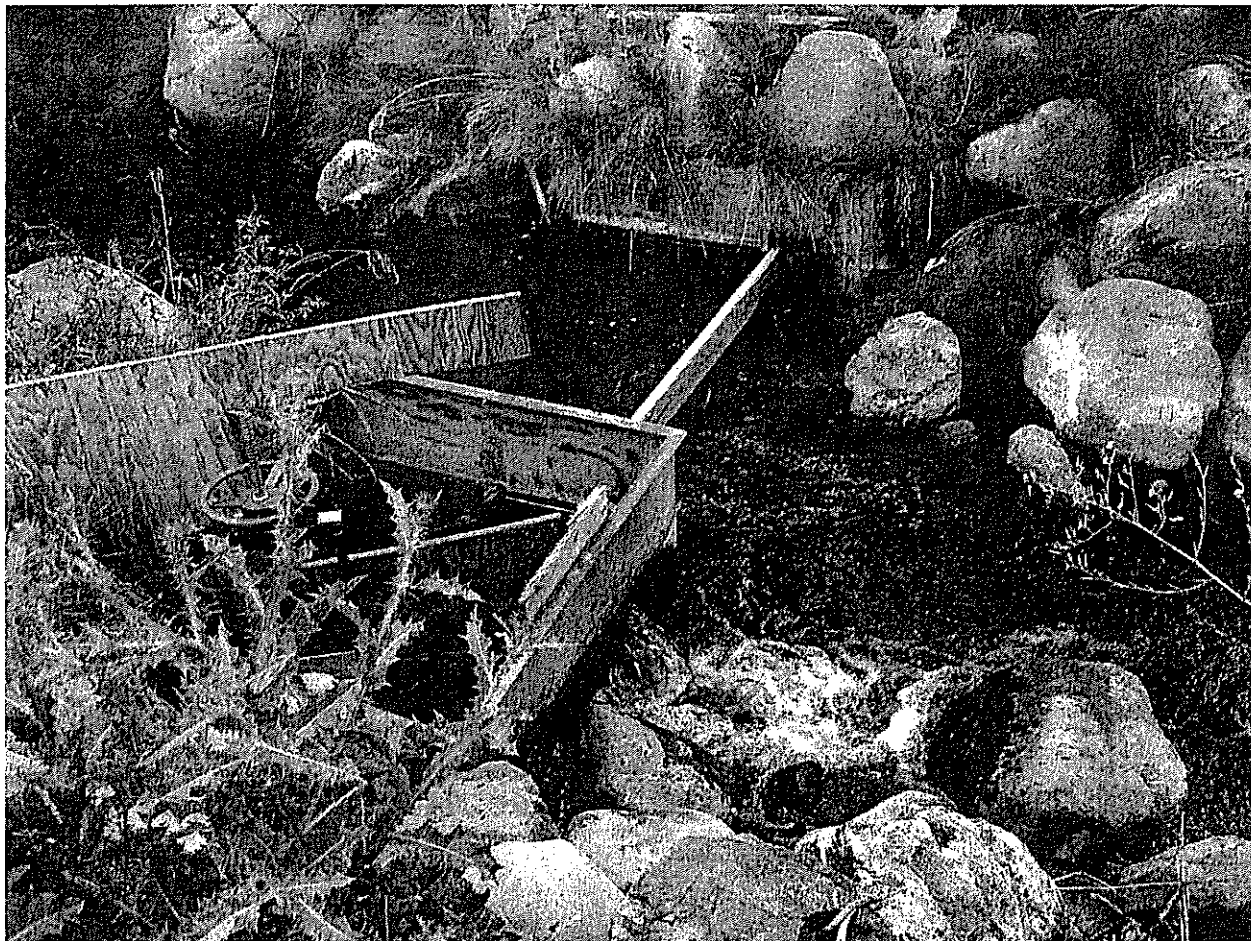
Two issues related to the bypass operation were reported by ODFW. Late in the operating season, no flow in excess of the diverted flow will be available for bypass, meaning that the bypass will be closed. This is a concern and violates the criteria the special FCA screen criteria. Also, I observed that even with flow available for bypass, fish are routed directly below the screens. I observed fish below the diversion structures. The three diversions provide a complete passage barrier to any fish interested in passing upstream (image 8).

Image 8, upstream passage barrier
